Controlling Moisture Migration with Advances in Polymer Technology

By: Robert R. Cain

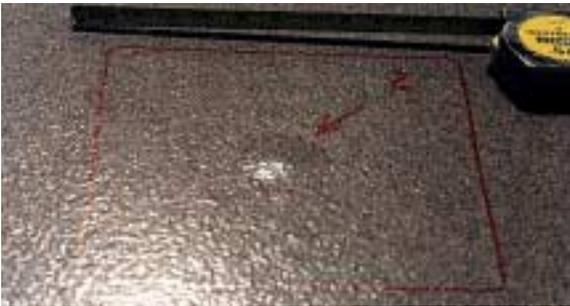
Moisture vapor transmission failure of epoxy quartz system.

The common mode of failure is blistering of the coating or floor covering. This blistering seems to relate in some way to a build-up of pressure. Lawsuits claiming hydrostatic pressure have been lost because there is not any detected in jobs exhibiting moisture migration.

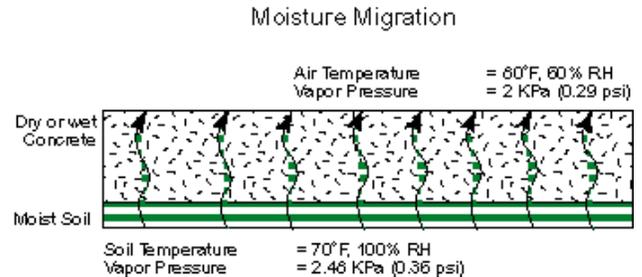
Figure A

In the past moisture migration through concrete has been mistakenly identified as moisture content in concrete. Concrete is considered to be dry when its moisture content is in equilibrium with the ambient conditions. Nearly everyone knows how to get a pretty good bond to concrete that has a high moisture content. It is when that moisture begins to move that problems start.

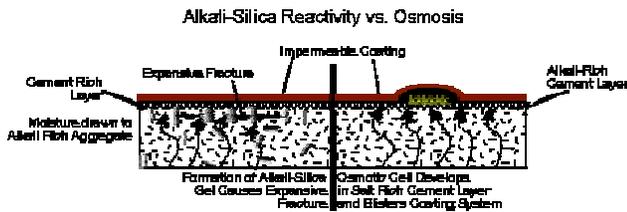
Figure B

Pressures generated by osmosis can greatly exceed other forces (e.g. adhesion) and ultimately cause the delamination of a coating or other surfacing on concrete. Three things are required for osmosis to take place: water (liquid or vapor), soluble salts (which are always found in concrete), and a semi-permeable membrane (the concrete itself). All three are part of the initial concrete mixture. The difference in soluble salt concentration, coupled with concrete permeability for inorganic salts between the top and bottom sections, have been identified as major contributors to the formation of an osmotic cell. Higher concentrations of soluble salts are typically found in the top section of the concrete and are the attraction for the moisture to migrate to the surface. As the concentration of salts accumulate and precipitate, pressures are formed which exceed the bond strength of most adhesives.

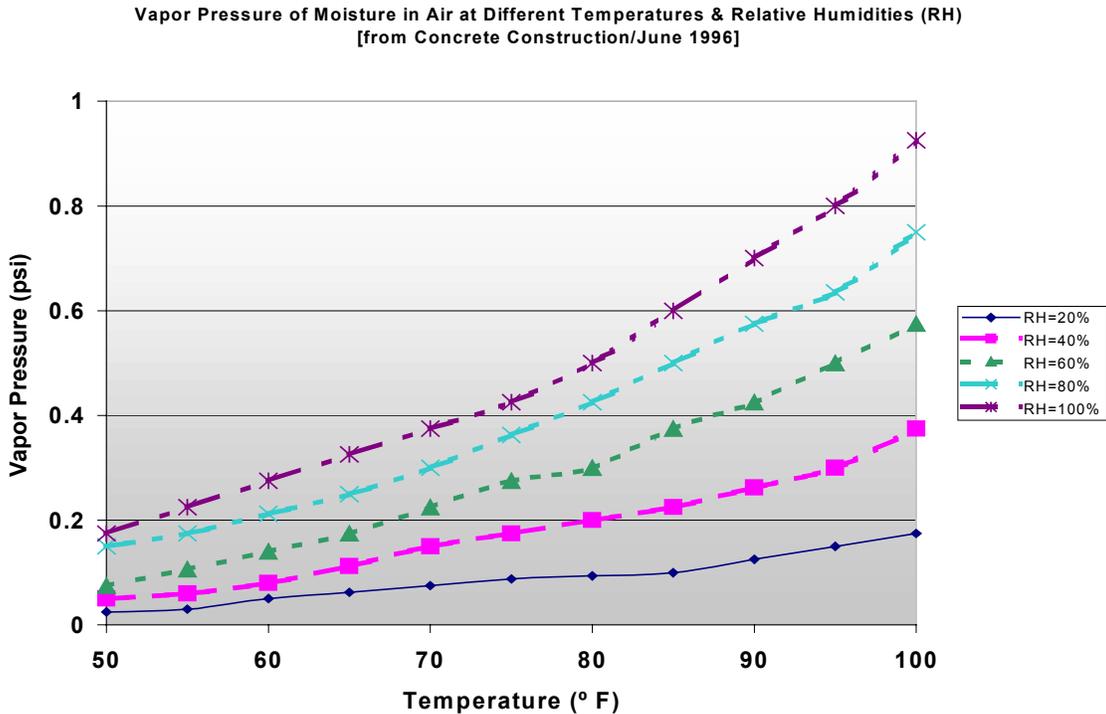
Figure C: The driving force for moisture movement through a slab is the differential in vapor pressure between the above slab and below-slab environments. Use this graph to determine the vapor pressure of moisture in air at different temperatures and relative humidity.

Water vapor will migrate to the surface when the vapor pressure in the concrete is higher than the vapor pressure in the air above the surface of the concrete. There are charts for determining the vapor pressure of air if the relative humidity and temperature are known.²

High pressure moves to low pressure, so the difference is the force driving moist air from in and below the concrete to the surface. Moisture passing through the slab can carry alkaline salts from the ground or the concrete itself. The upward drive is the contributor to the osmosis and ASR which accumulate the salts. It causes high alkalinity and pressures sufficient to cause bond and adhesion failures.

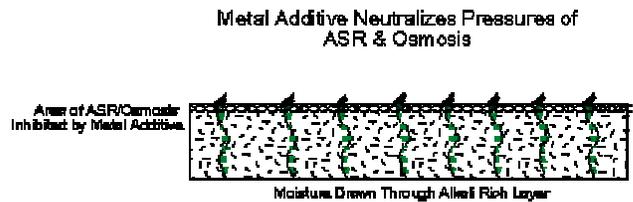
Figure D

The use of a metal additive (K-911) has been found to neutralize the alkali-silica reactivity at the surface and eliminate the pressure buildup caused by ASR reactivity. Metals of sodium and potassium actually contribute to ASR but K-911 acts to pacify the surface to stop further activity.
